**RAILWAY INVESTIGATION REPORT  
R02W0060**

**MAIN-TRACK DERAILMENT**

**CANADIAN NATIONAL  
FREIGHT TRAIN E-201-31-24  
MILE 251.3, REDDITT SUBDIVISION  
WINNIPEG, MANITOBA  
26 APRIL 2002**

Report Number R02W0060

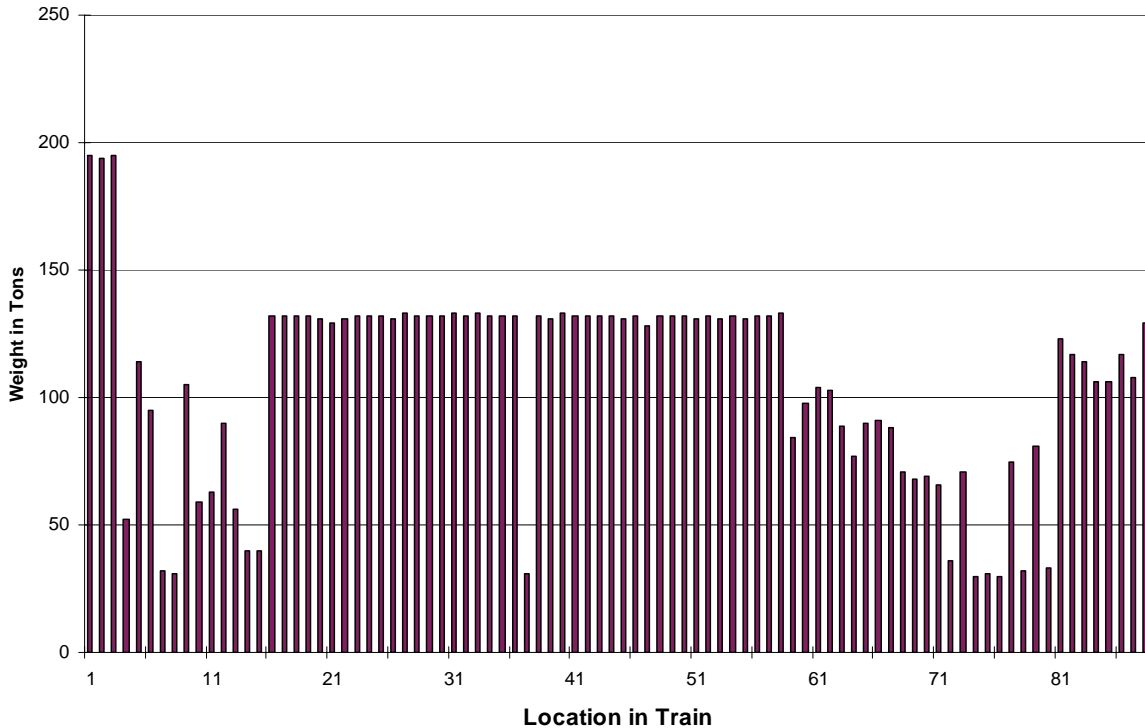
locomotive, in compliance with CN's dimensional load handling instructions. The two empty bulkhead centre-beam flat cars were within this block and subsequently moved to the head end of the train. Figure 1 below illustrates the tonnage (weight) distribution of the train.

**Figure 1.** Tonnage distribution for train 201, starting with the locomotives at position 1

CN requires that the dimensional load be placed at the head end of the train. Subsequently, the cars within that block were also moved to the head end of the train. This placed two long, empty bulkhead centre-beam flat cars near the head end of the train, with 90 per cent of the train's tonnage (8455 tons) trailing the empty cars. Previous TSB accident assessments and investigations have identified similar train configurations as factors contributing to several accidents. The train configuration of empties ahead and loads behind, combined with the presence of three locomotives equipped with high-capacity extended-range DB and a train-handling policy emphasizing the use of DB as the initial braking force, increased the risk for a derailment initiated by track/train dynamics to occur.
